ST ANDREW'S PARISH CHURCH

DONHEAD ST ANDREW

STATEMENT OF SIGNIFICANCE

(revised 28th April 2016)

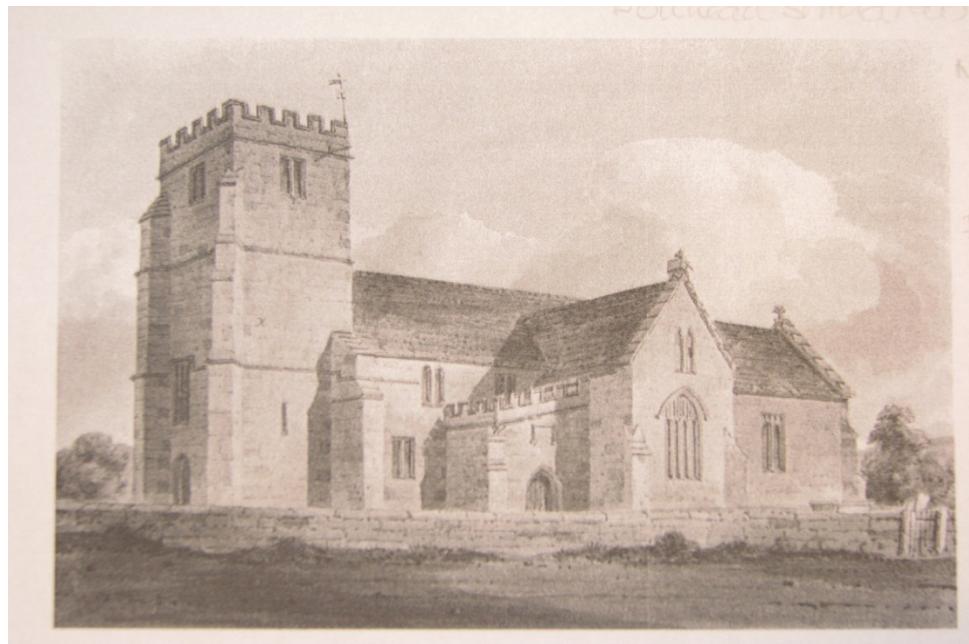
Most of what is seen of the Church in this painting is late mediaeval; this view of the south and west elevations show that the Church had a south transept and attached

porch; the porch and tower were battlemented. The windows seen above the porch may have been in a chamber above the south aisle.

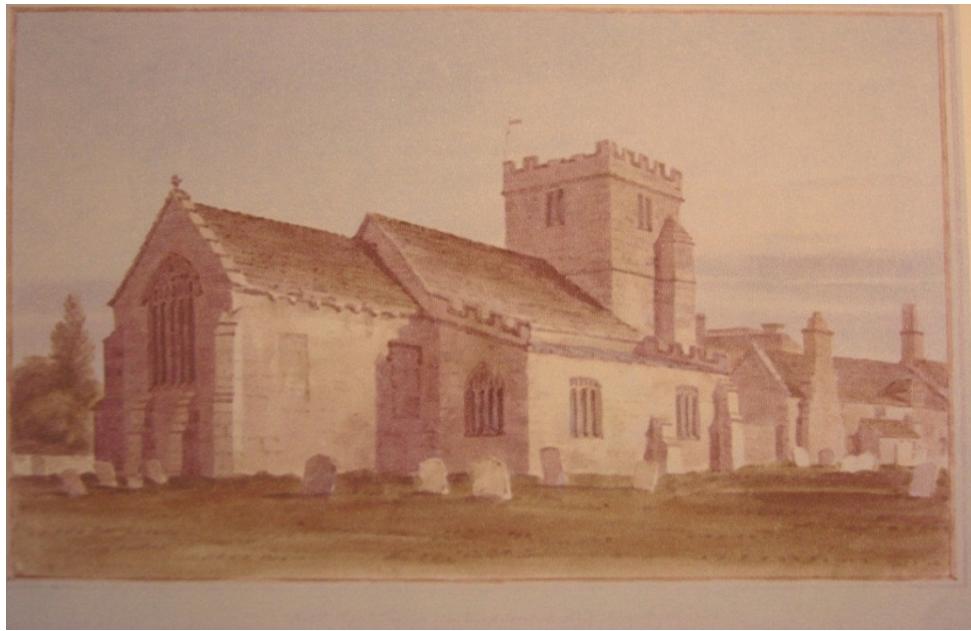
The view of the north and east elevations show that the Church has a north aisle rather than a transept. The windows on the north wall of the Chancel had been blocked to avoid window tax. Part of the Rectory can be seen to the right beyond the tower.

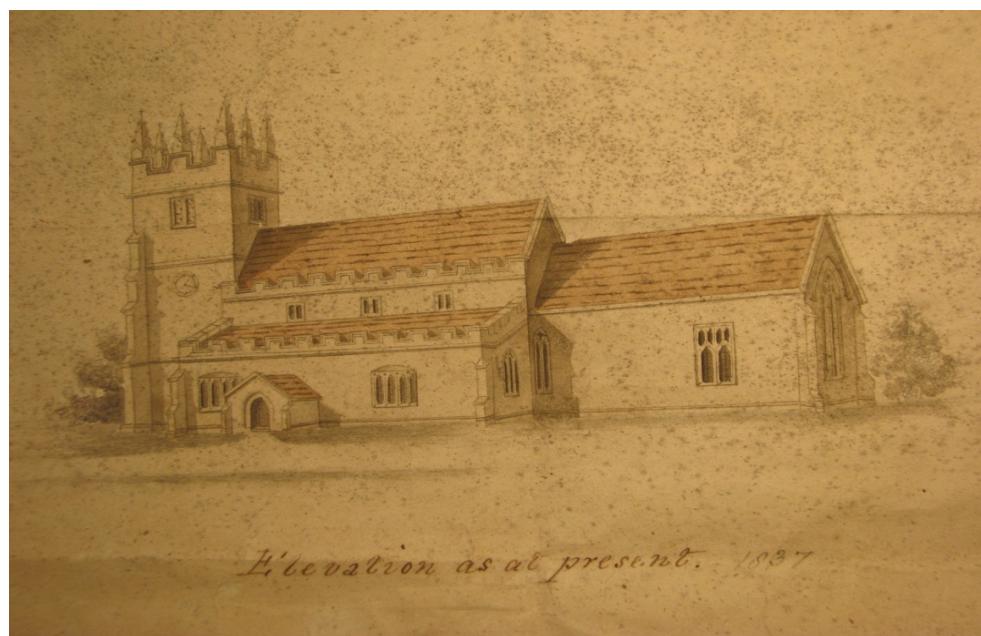
1837

The chancel was taken down and re-built in circa 1833. The tower then had eight pinnacles and a clock on the south face. The south transept and attached porch have been replaced with a south aisle and smaller porch. The Nave roof and south aisle parapets both have battlements. The south aisle stretches the length of the Nave.

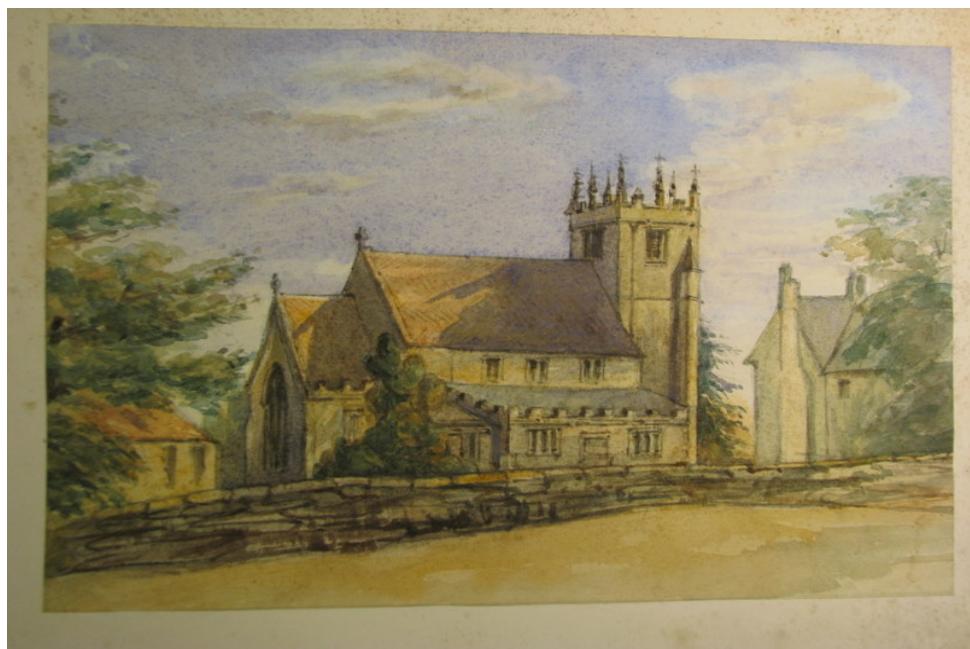
1850.

The Nave roof has now been lengthened and the Chancel and north aisle parapets both have battlements, whereas the Nave roof does not. The original Church School, built by the Reverend William Dansey, Rector from 1820 to 1855, can be seen in the churchyard to the east of the Church.

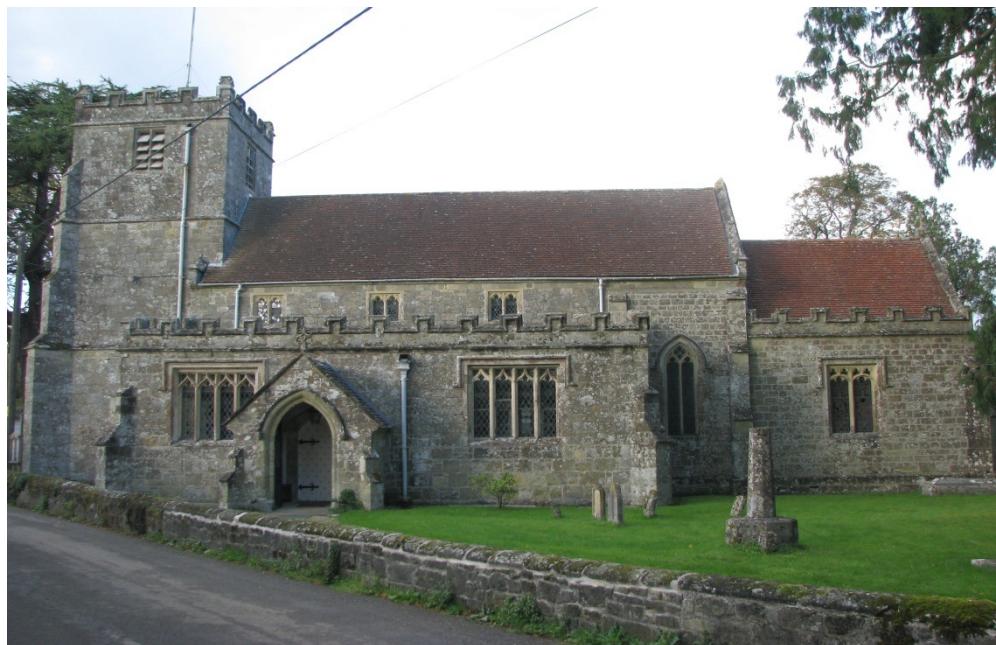
The 19th century extension of the Nave roof over the chancel is clearly shown by the different stonework between the buttresses on either side of the tall Chancel window.

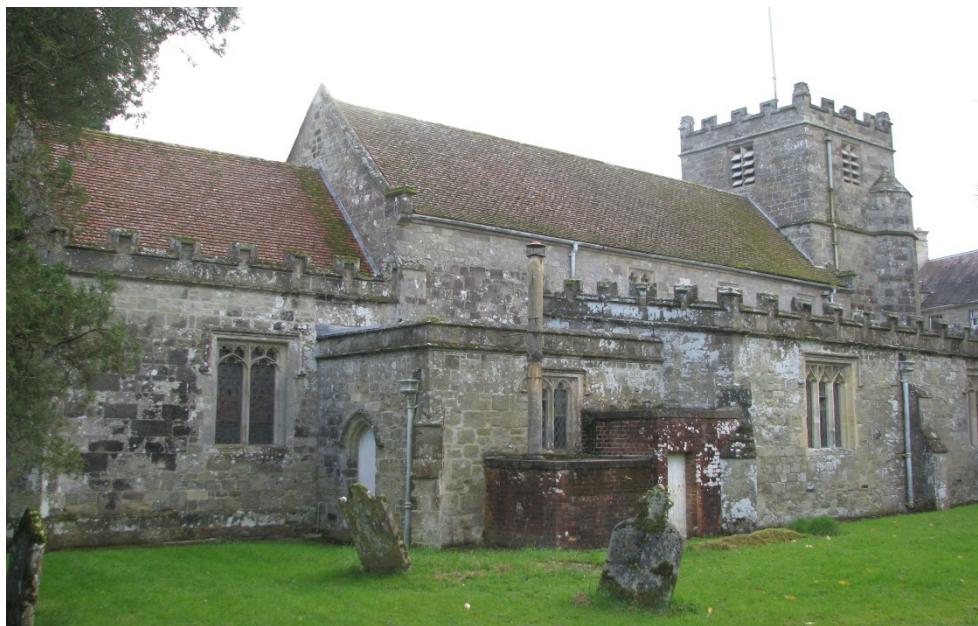
The brick-built boiler house and flue are seen in the corner between the Vestry and north aisle.

It is partly on the footprint of this boiler-house that the new extension will be built, reaching a further 2.5 metres into the Churchyard.

1. Asbestos has been discovered in the 1920s boiler house and in the heating pipework under the raised wooden platforms on which the pews sit. The areas of asbestos have been professionally inspected. A plan and costing for a specialist company to remove all the asbestos once the church closes for the Development Project has been incorporated into the Project budget and timetable.
